# *the* Conduit

Summer 2008

## Recovery Boiler Lower Furnace Problems

**By Ronald Lansing, P.E.  
and Max Moskal**

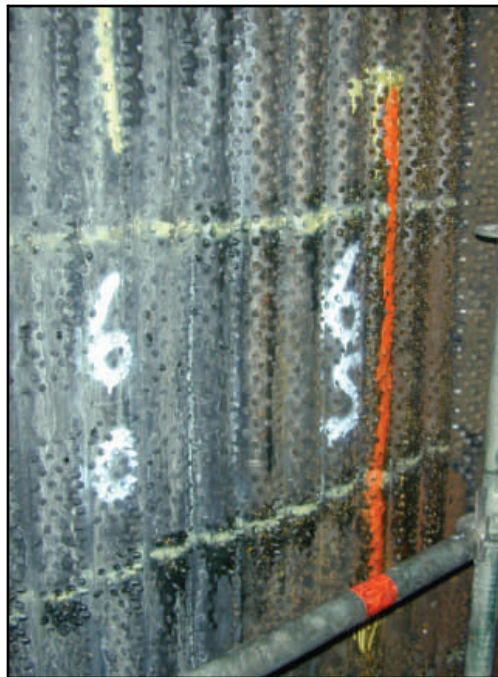
The studs would corrode away by sulfidation at rates dependant on the liquor and/or smelt chemistry and temperatures. The tube wall thickness would also become thinner (Figure 1). Many low-pressure boilers still operate and experience long life with studded

Figure 1. Lower furnace studded tubes can become thin and difficult to test with UT between the studs. Thinned tubes can be seen in the orange area.

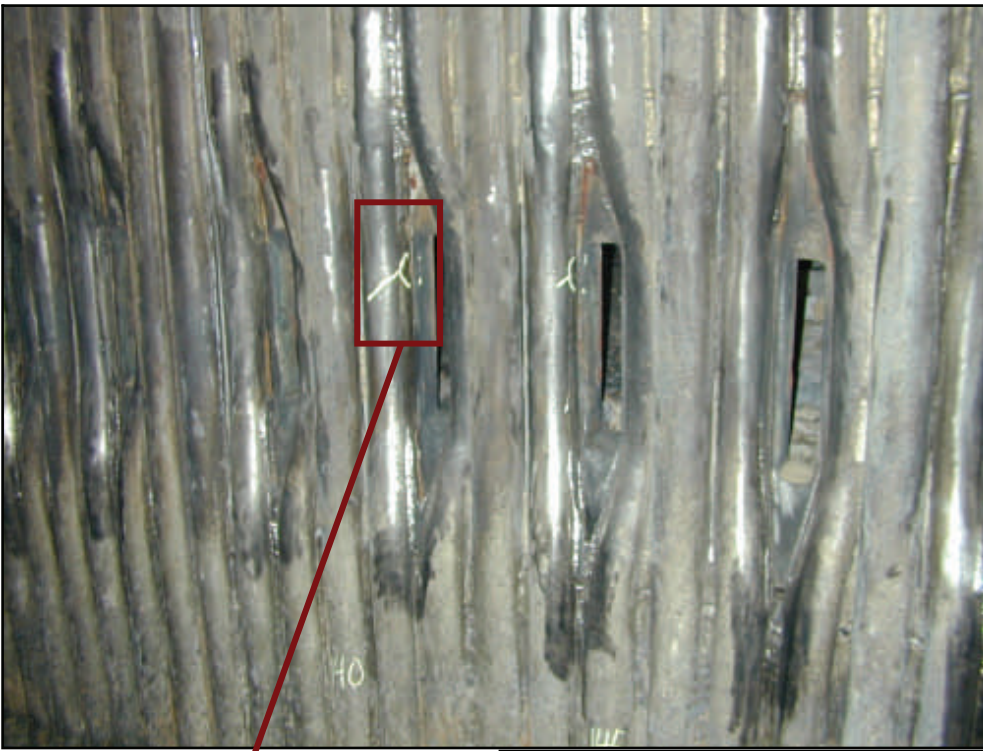
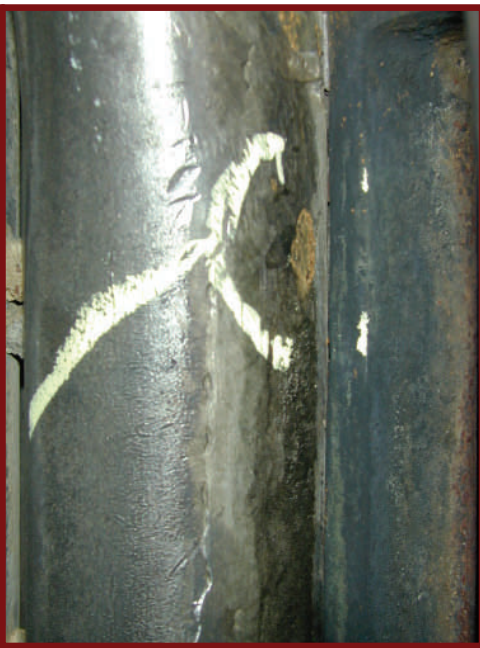
that the thinning mostly occurred in the stainless steel. Small bald spots (Figure 2) thin much slower and could be more easily monitored and re-clad as necessary. Many mills used weld overlay, such as Type 309L stainless steel, to repair bald spots at air ports. Experience has shown that the overlay corroded as fast as the original cladding, if not quicker. Nickel-based alloys were also not satisfactory in repairing bald areas.

Figure 2. Primary air port "balding" (rusty steel exposed) shown in both images.

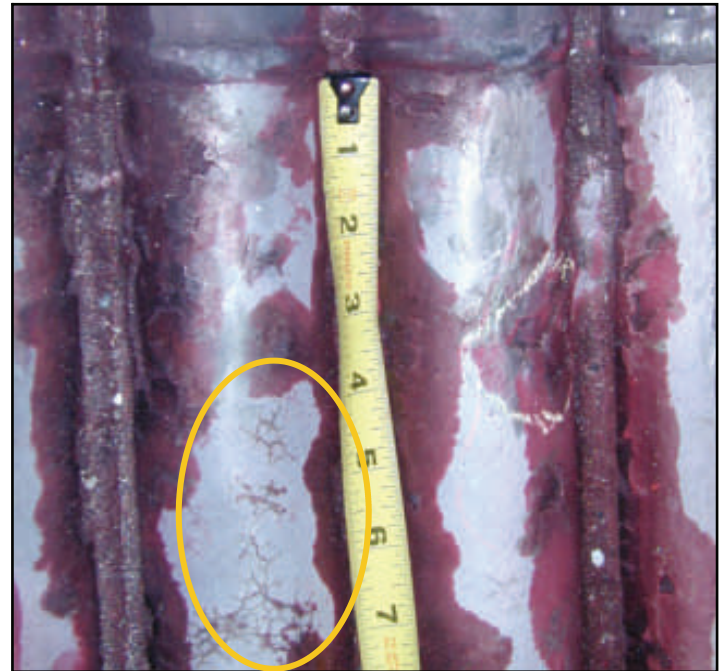
Repeated weld overlay invited cracking of air port tubes. Some boilers have been rebuilt with "modern" air distribution systems for better efficiency. However, some of these air port designs have resulted in wide temperature fluctuations at the air port tubes with thermal fatigue cracking as the consequence. Removing fin and crotch plate welds has limited air port crack sites. Alloy 625 and Alloy 825 weld overlays have been found to be more resistant to air port thermal cracking than the original stainless steel. Floor tube stress corrosion cracking (Figure 3) under the smelt bed was found to be due to

contact with hydrated smelt in the critical tube temperature range of 300°F to 400°F. Most of these cracking problems occurred when boilers were reheated above 300°F for dryout while the tubes were in contact with the smelt. The cracking that had been tested using penetrant dye testing seemed to be present mostly within the stainless clad metal and self-arrested areas at the carbon steel interface. If cracking in floor tubes occurs, it is often best to wait until cracking becomes more widespread to replace the tubes, and then use the Alloy 625 or Alloy 825 (nickel base) weld overlay on the floor. The floor tube cracking has been regularly monitored in some boilers in-lieu of wide spread cladding replacement.

Figure 3. SCC cracking on a stainless steel clad floor tube can lead to spalling (circled).

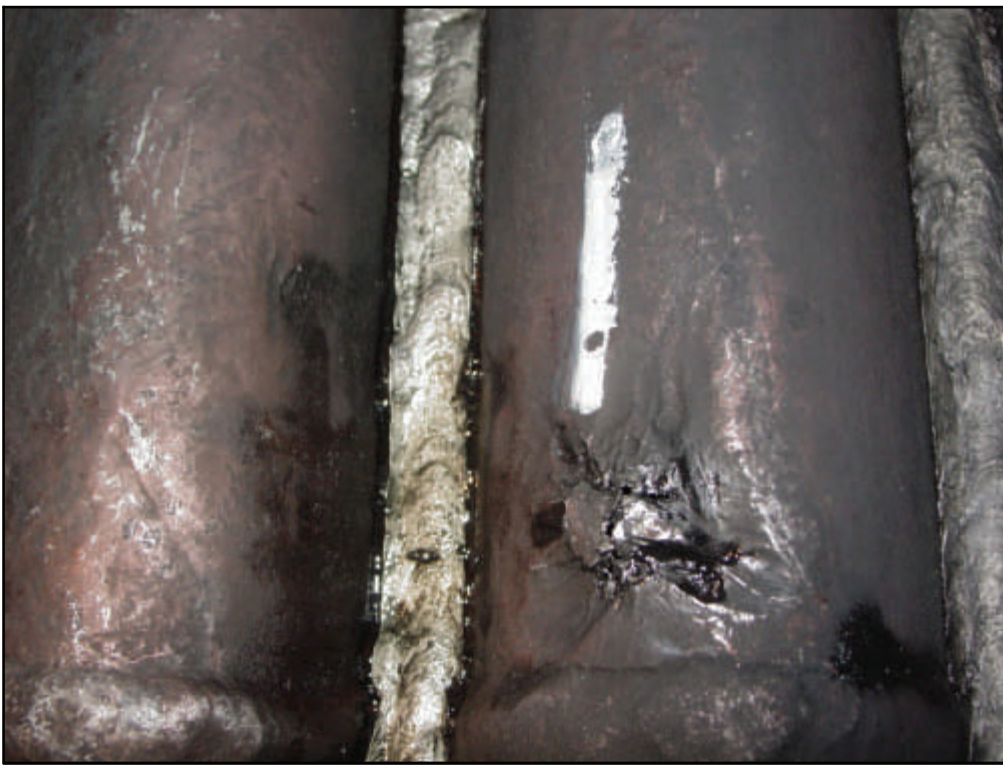
boilers have decanting bottoms, which are not as sloped as the original floor designs. The almost horizontal floor tubes can be prone to low-flow problems, sometimes leading to localized tube

Figure 4. Floor tube leak at weld. The low flow of the horizontal tube combined with weld drop-through initiated DNB boiling tube overheating/thinning.

overheating (Figure 4). In addition, sagging can cause “puddles” in the floor, which may further inhibit flow (Figure 5).

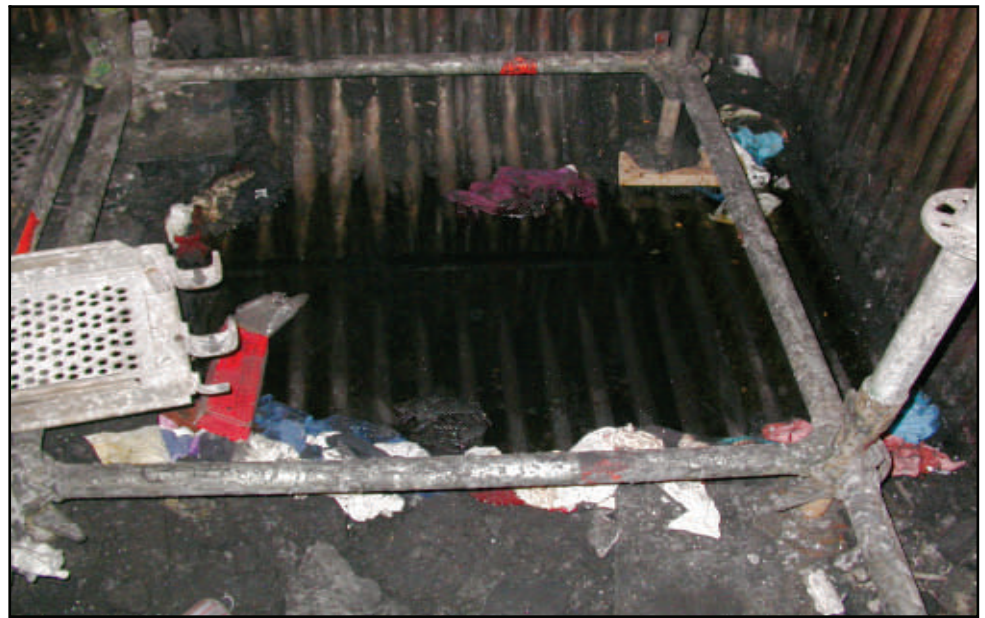
Figure 5. Decanting floor “puddle” area with smelt bed removed.
